INSTALLATION RESTORATION  
PROGRAM RECORDS SEARCH

CANNON AIR FORCE BASE, NEW MEXICO

August 1983

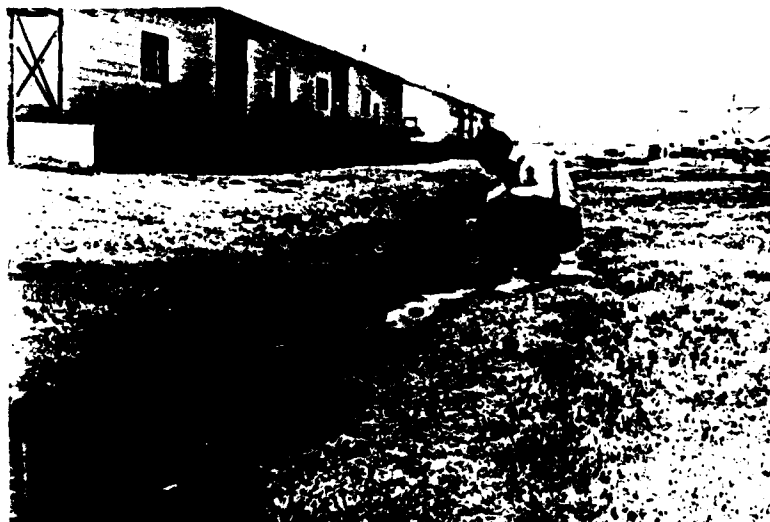
The bottom of the ditch was observed to have a black color and a characteristic POL odor.

Site No. 15—AGE Drainage Ditch (Looking Northeast)

1. A limited Phase II monitoring program is recommended for the zone consisting of the two sites, No. 9 and No. 5, and Sites No. 15 and 6, to confirm or rule out the presence and/or migration of hazardous contaminants. The location map of sites recommended for limited Phase II monitoring is shown on Figure 2. This program includes installation of upgradient and downgradient monitoring wells for sampling ground water at the zone consisting of Sites No. 9 and 5. Soil sampling is recommended at the Fire Department Training Area No. 4 (Site No. 9), the AGE Drainage Ditch (Site No. 15) and the Fire Department Training Area No. 1 (Site No. 6). The priority for monitoring at Cannon AFB is considered low to moderate. Details of the limited Phase II monitoring program are provided in Section VI and in Appendix J of this report.
